Endeavour STS-108

Space Shuttle Program

SSME Flight Readiness Review

November 15, 2001

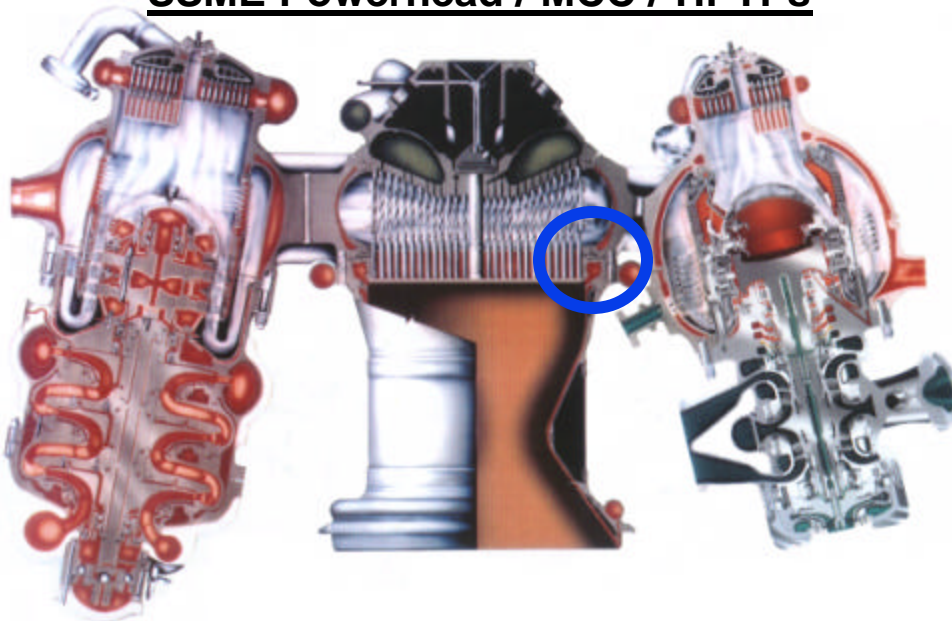
SSME Powerhead / MCC / HPTPs

- **All potential migration paths evaluated**
 - Limited paths due to piece size and geometry
- **Engine Coolant Circuit unaffected**
 - Minimal blockage potential
 - Worst case - isolated LOX post tip erosion (Crit 3)
- **Impact potential minimal**
 - Inadequate energy to cause damage
 - LPF discharge duct, HGM coolant duct and liner, fuel sleeves
 - Migration out BLC holes during operation
 - Potential to strike and rupture two nozzle tubes
 - No significant affect on engine performance, redline margins and ability to complete mission
 - Migration to HPTP turbines in zero g environment
 - Verified clean pre-flight with visual inspections and torque checks
 - Below safe impact size for heat exchanger

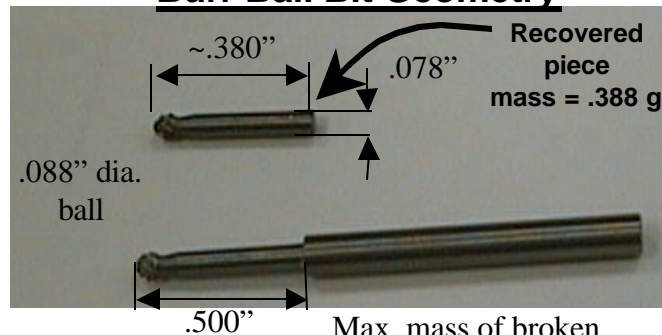
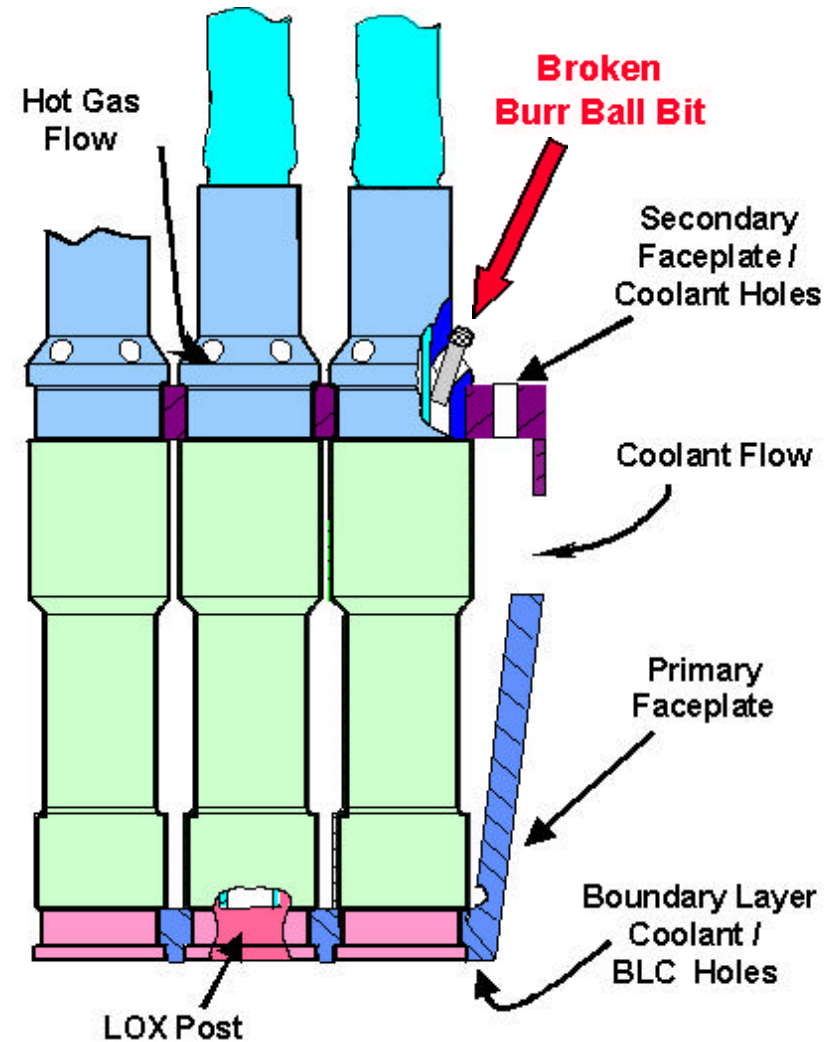
Burr Ball Bit Geometry

Broken Burr Ball Bit

- **Issue**
 - FOD found in Engine 2052 / Powerhead 6009
- **Background**
 - Burr ball bit found in main injector hot gas cavity during routine STS-105 post flight borescope inspections
 - Lodged in LOX post outer row secondary faceplate retainer hole
 - Piece size: .078" dia x .380" long (.388 grams)
 - Piece retrieved - inspections revealed no discernable hardware damage
 - E2052 / PH 6009 Operational History
 - E2052
 - 5 starts / 2713 seconds (4 flights)
 - PH 6009 (used with Block IA E2039 and Block IIA E2052)
 - 11 starts / 5397 seconds (8 flights)
 - Engine performance as expected - no performance or structural anomalies

- **Unable to determine timing or specific operation being performed when bit broken**
 - Boundary Layer Coolant hole drilling most probable event
 - BLC holes maintain adequate cooling of MCC hot gas wall
 - Operation can be done at Canoga, SSC and KSC
 - 7 BLC holes required per design
 - Additional holes opened as needed (per specification and/or MR action)
 - BLC opening opportunities on E2052 / E2039
 - 12 BLC holes opened in June '95 (10 tests / flights since)
 - 7 BLC holes opened in February '99 (5 tests / flights since)
 - Operation improved in May '99
 - Standard drill bit replaced burr ball bit

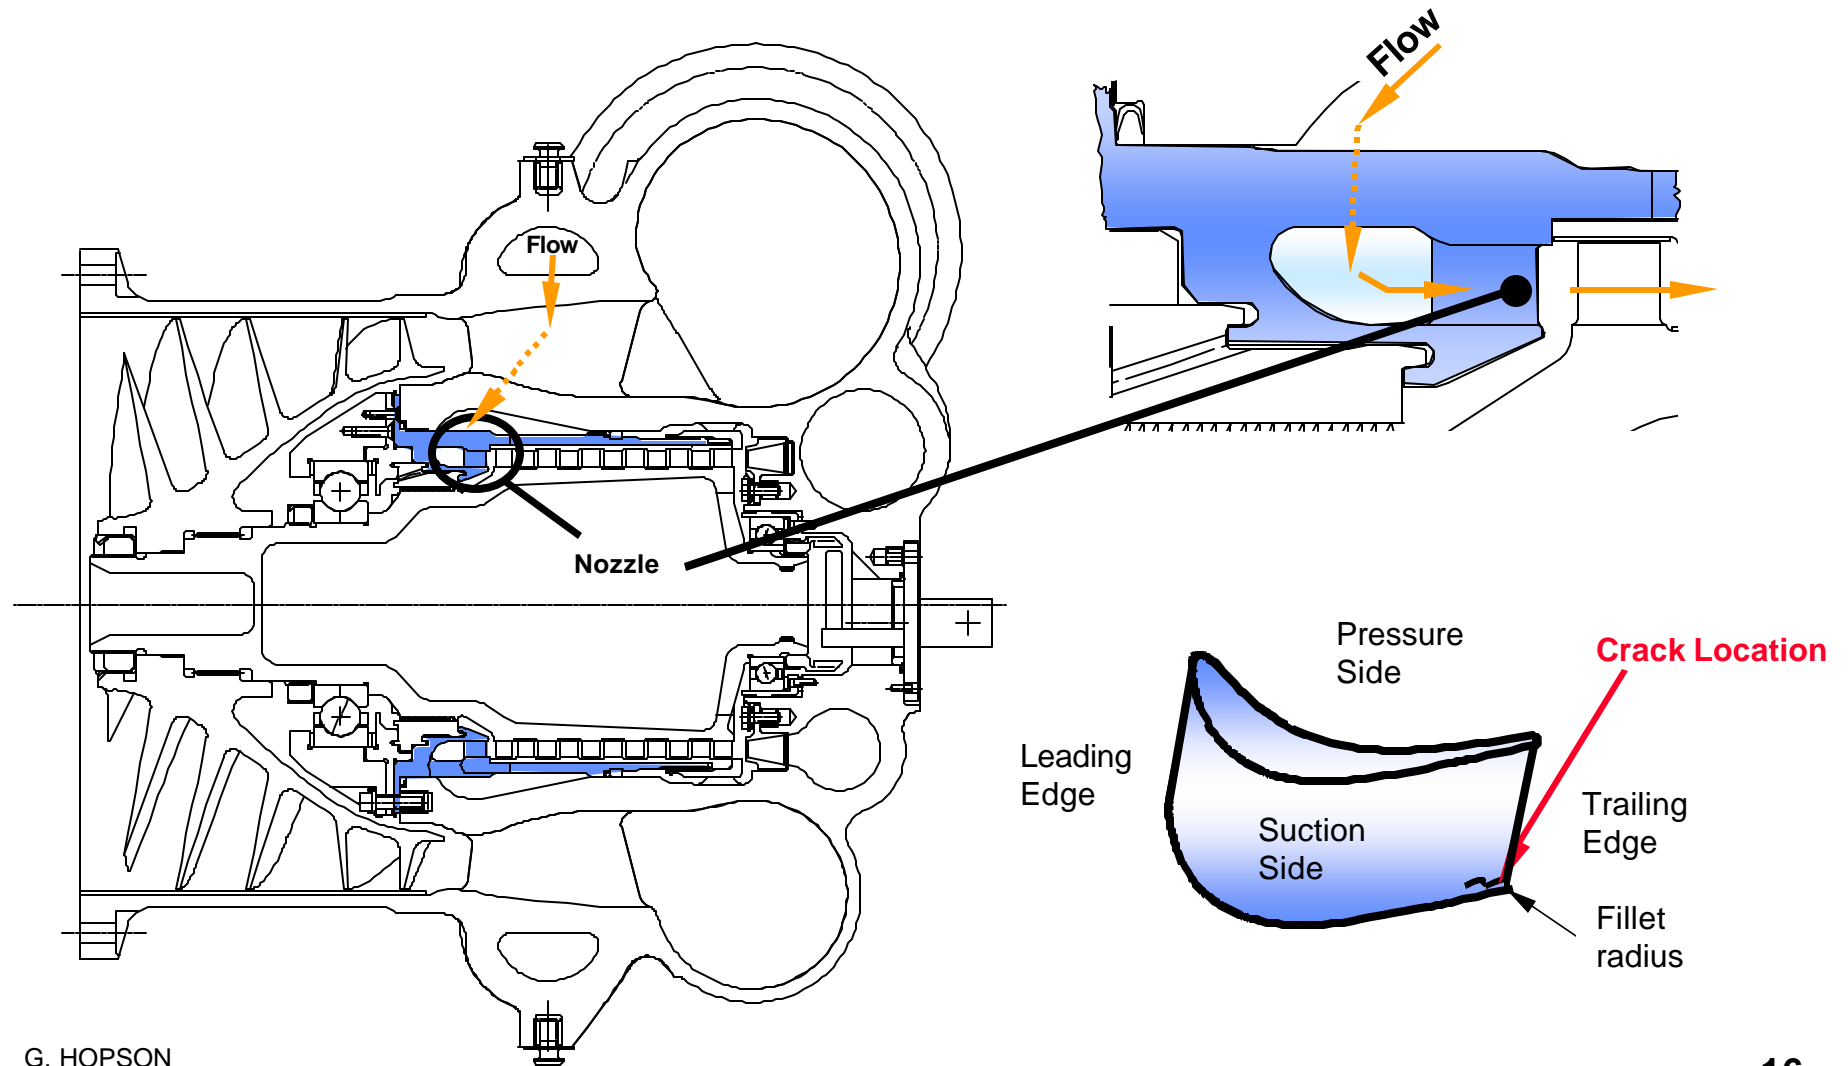
LPOTP Nozzle Vane Cracking

- **Issue**
 - Cracking of nozzle vane trailing edge fillet radii discovered in moderate time LPOTP nozzle
- **Background**
 - Penetrant inspection being completed as part of Block II retrofit
 - S/N 4877663: 20 starts / 7642 seconds
 - Two prior occurrences of HCF induced vane cracks
 - 1) 16 vanes cracked (96 starts / 36,529 seconds)
 - 2) 2 vanes cracked (82 starts / 34,819 seconds)
 - Existing life limit per DAR 2956
 - Life limited to 18,129 seconds (50% fleet leader)
 - Penetrant Inspect at 9064 seconds (25% fleet leader)

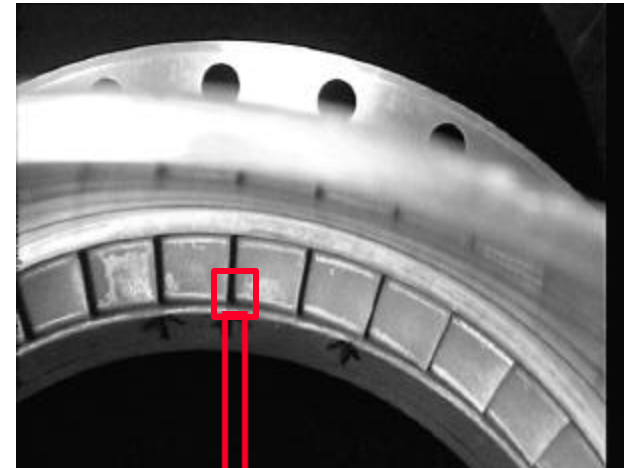
Nozzle Vane Assembly
Upstream View

- **Crack Verified by Sectioning**
 - Trailing edge through wall
 - Pressure side length = .107"
 - Suction side length = .065"
 - Pressure side initiation with apparent stable crack growth through to suction side
 - HCF initiation and propagation
 - Multiple initiation sites
 - No evidence of crack growth towards vane leading edge
 - Crack remains in vane fillet radius
 - Very little smearing of fracture surfaces
 - Suggests little relative displacement between fracture surfaces

- **Vane Inspections**
 - Penetrant inspection of all remaining available nozzles
 - Including pressure side fillet radii
 - Dimensional inspection of representative sample of vanes
 - Including vane thickness and fillet radius
- **Materials Analyses**
 - Additional sectioning of indications from other nozzles
 - Confirm HCF cracking mechanism
- **Structural Analysis**
 - Completion of refined analysis
 - Verify tolerance to defects and structural margins

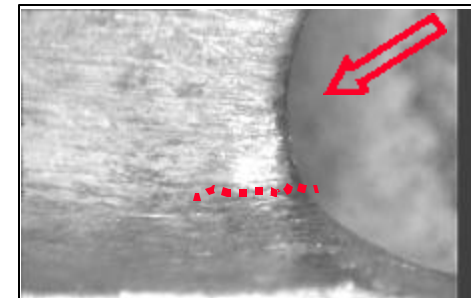
Trailing Edge, Cracked Vane

- **Casting and Fabrication Process**
 - Unchanged throughout program history
 - Not uncommon to require some blending of trailing edge radii to remove suspected casting defects
- **Investigation / Reinspections**
 - Additional penetrant inspections completed (heightened sensitivity to entire vane fillet radius)
 - Cracks characterized as “tight”
 - Pressure side of vane (crack initiation site) is “hidden surface” not normally inspected
 - Cracking noted in 9 of 18 vane assemblies (50 total vanes)
 - Range in operational times from 4773 seconds to 37,500 seconds (fleet leader)
 - Most all cracking located on trailing edge ID fillet radii
 - Some indications at trailing edge OD fillet radii
